Geologic Setting of Mosul Dam and Its Engineering Implications

September 2007

Final report

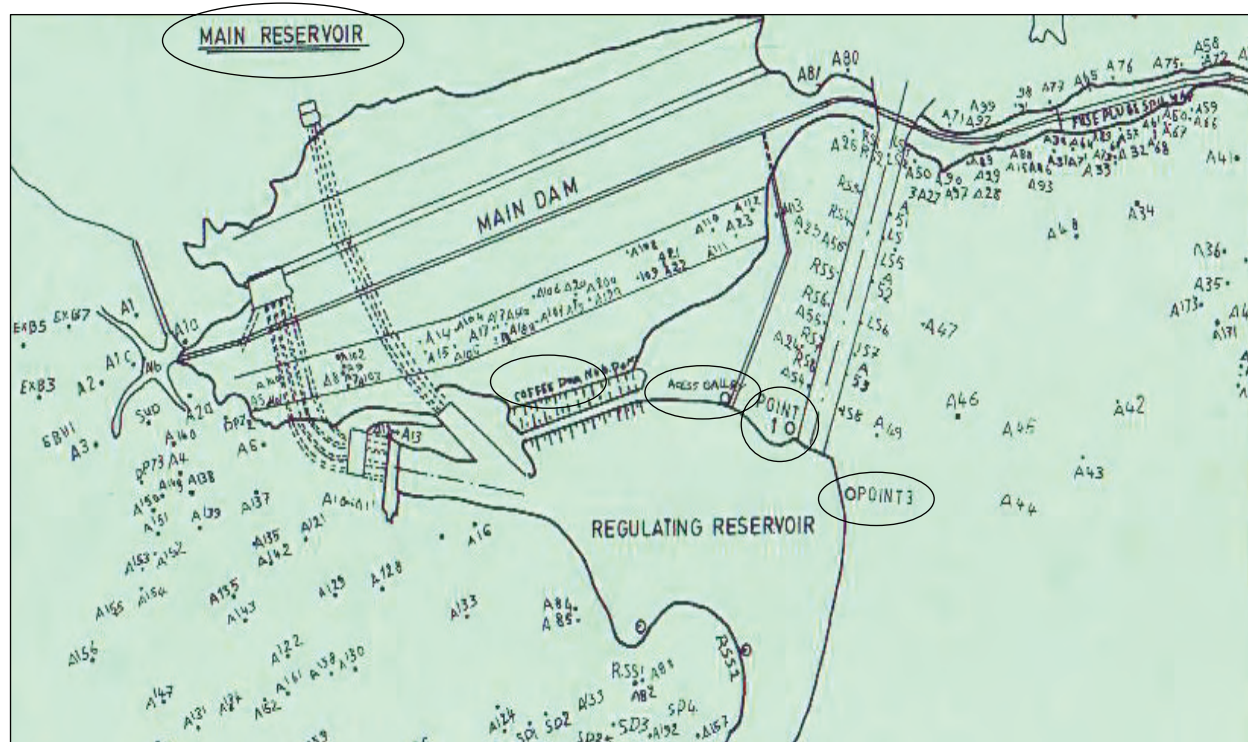
Figure 11. Locations of seepage monitoring and piezometers at Mosul Dam. Note especially Point 1 and Point 3, circled in red to the right-center of the map, corresponding to SP1 and SP3 in the text.
